ENGINEERING FAILURES LESSONS TO BE LEARNT

IN MODERN TIMBER DESIGN

June 2024

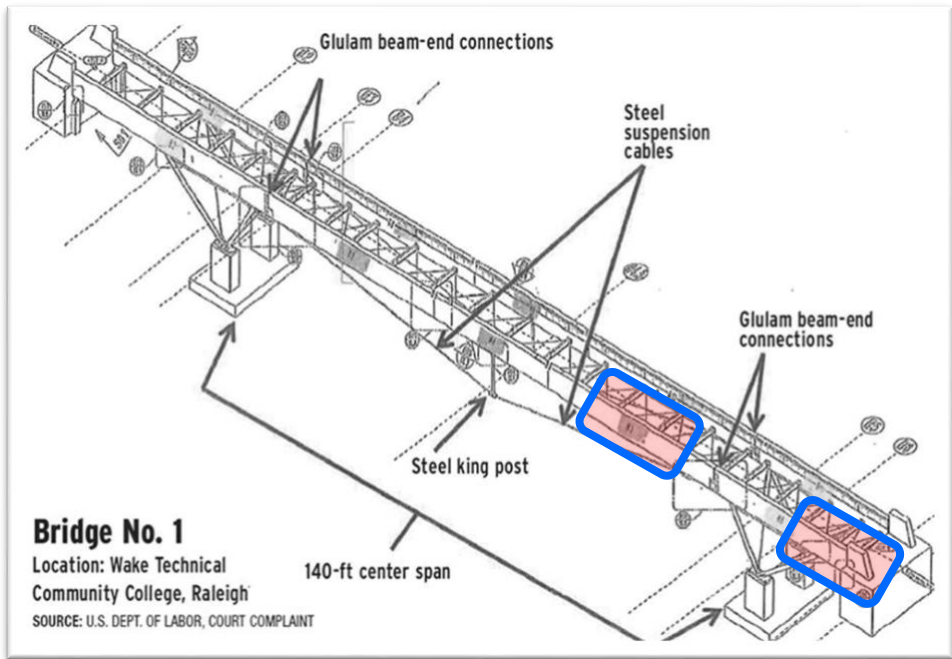
The glulam girders were too long to be shipped in one piece. Two splices were designed 11 metres apart along the span – see left hand rectangle in red.

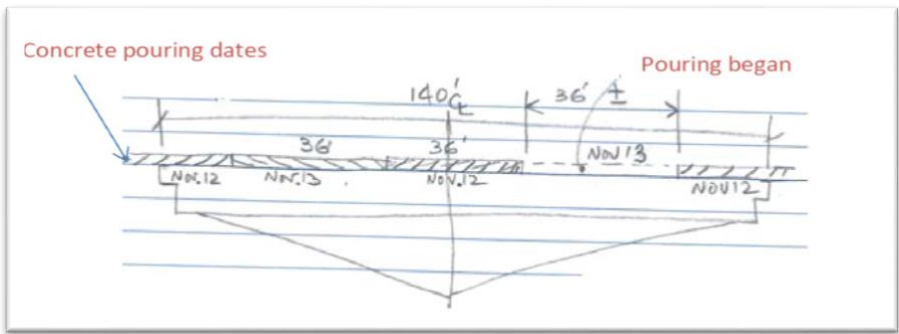
The Failure Bridge 1

The failure initiated at the splices and supports, which all had unreinforced notched supports.

1. Design flaws:
 - Inadequate design of notched connections in glulam beams, failing to account for tension perpendicular to grain.
 - During the shop drawing process it was agreed to introduce camber to the beams by tensioning the cables
 - The tension in the cables introduced tension stressed into the notches
 - The deck was attached at the bottom of the beams, pulling down the underside of the beams
2. Construction and quality control:
 - Lack of proper reinforcement at notched connections, the design engineer ignored the design standards and did not design/check the notches.
 - Inadequate site supervision and quality control.
3. Regulatory oversight and peer review:
 - Although the design was reviewed and checked at several stages by different entities, including the glulam manufacturer, the notches were never flagged as a potential design issue.

- The cause of the failures was the structural design flaw from the notched glulam girders
- The notches were not in compliance with the applicable ANSI/AF&PA NDS-2005
- Several consultants did not notice the presence of the notches or neglected the opportunity to raise concern

2. Design Considerations:
 - Properly account for timber's anisotropic properties in structural designs.
 - Use reinforcement techniques where necessary, especially for tension perpendicular to grain.

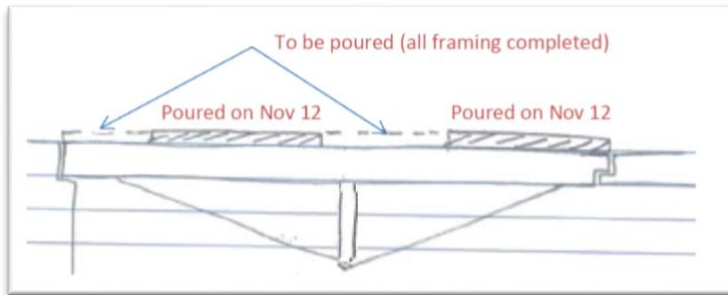
The Failure Bridge 2

- One bridge collapsed during concrete deck pouring, resulting in one fatality and four injuries.
- The second bridge collapsed two days later under its own weight.

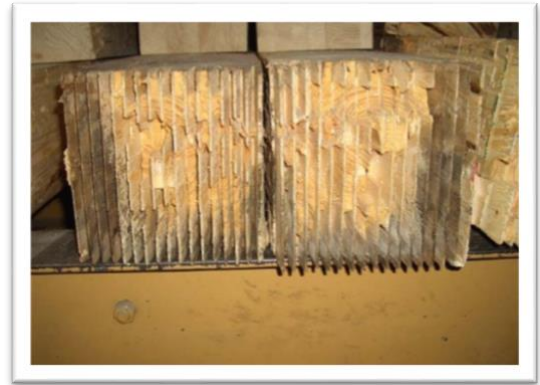
- Mistakes in design calculations.
- Use of finger-jointed timber sections without considering net section properties.
- Box girders were higher than allowed in appraisal (2.87 meters instead of 1.20 meters).
- Use of box beam sections that trapped moisture over time. Inadequate consideration of long-term moisture effects on the structure.

- Improper gluing techniques in the manufacture of box beams, the gluing between flanges and webs was not carried out according to the state of the art.
- Inappropriate use of urea-formaldehyde adhesive in a high-moisture environment.
- Water damage further weakened the finger joint.

- Avoid closed sections that can trap moisture in long-span structures. If closed sections are used, building physics principles should be applied to estimate the likely environmental conditions in the beam cavity.

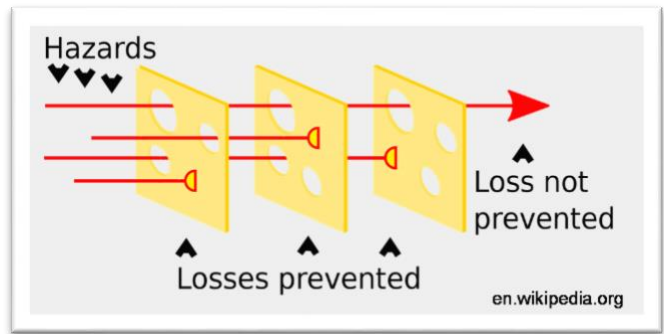
**Multiple point of failures
(Swiss cheese model):**

- Design mistakes
- Formal/regulatory failures
- Manufacturing/Construction failures
- Maintenance failure

Leading to a progressive failure mechanism

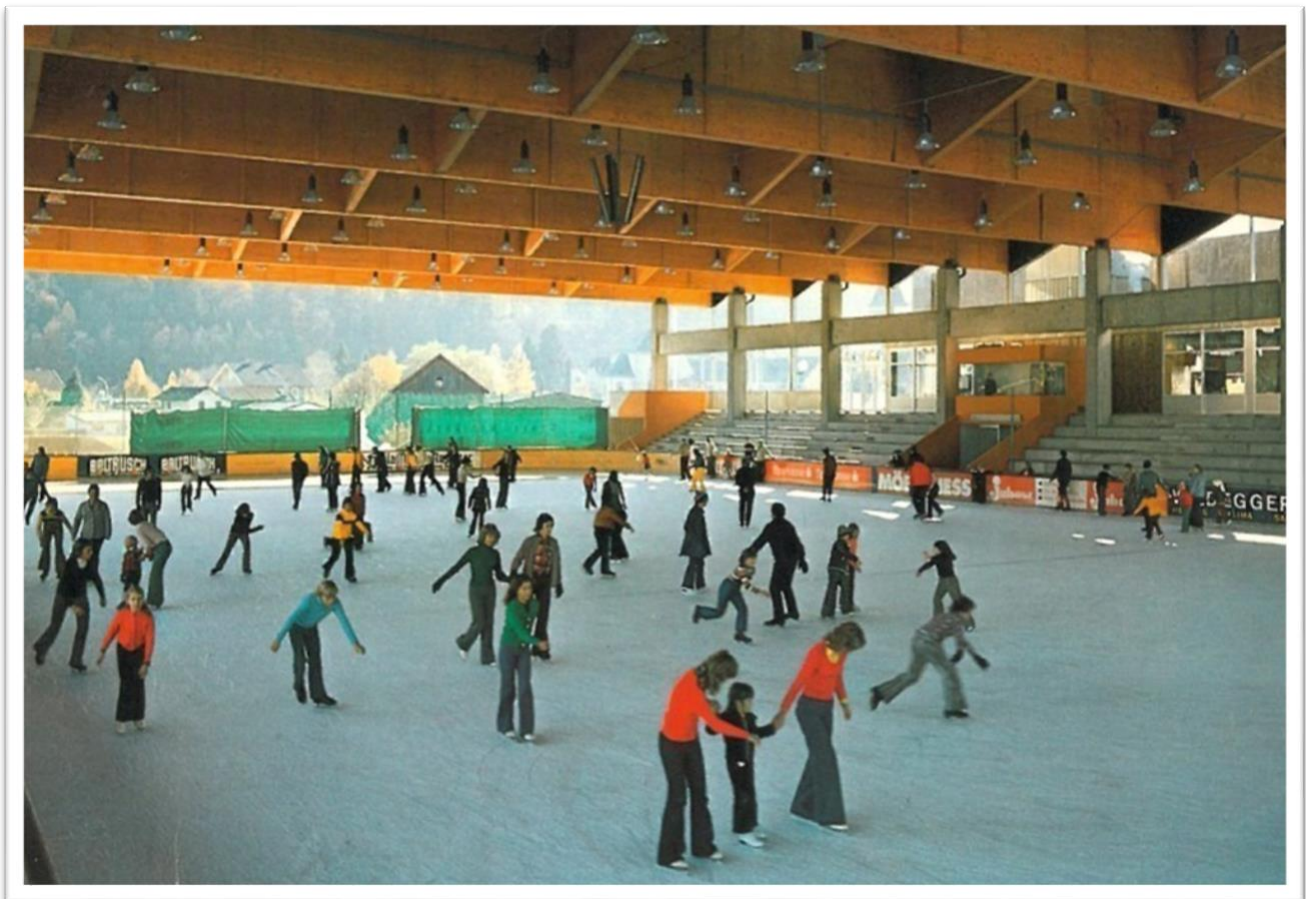
- The roof collapsed in 2006, 34 years after construction, resulting in 15 fatalities and 34 injuries.
- The collapse occurred under snow load, though the load was within design parameters.
