ENGINEERING FAILURES LESSONS TO BE LEARNT

IN MODERN TIMBER DESIGN

June 2024

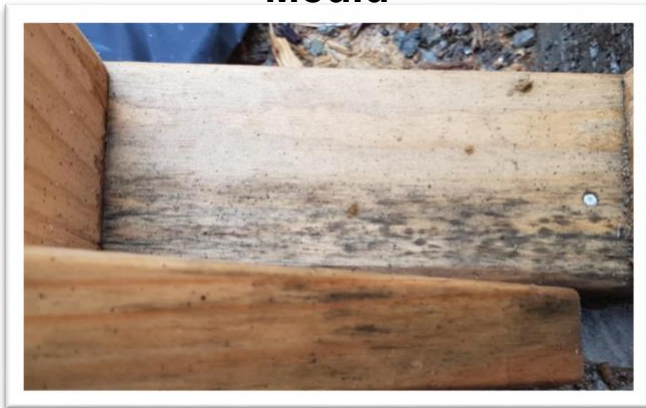
Mould

3. It can be susceptible to mould and rot if moisture content remains elevated for extended periods.

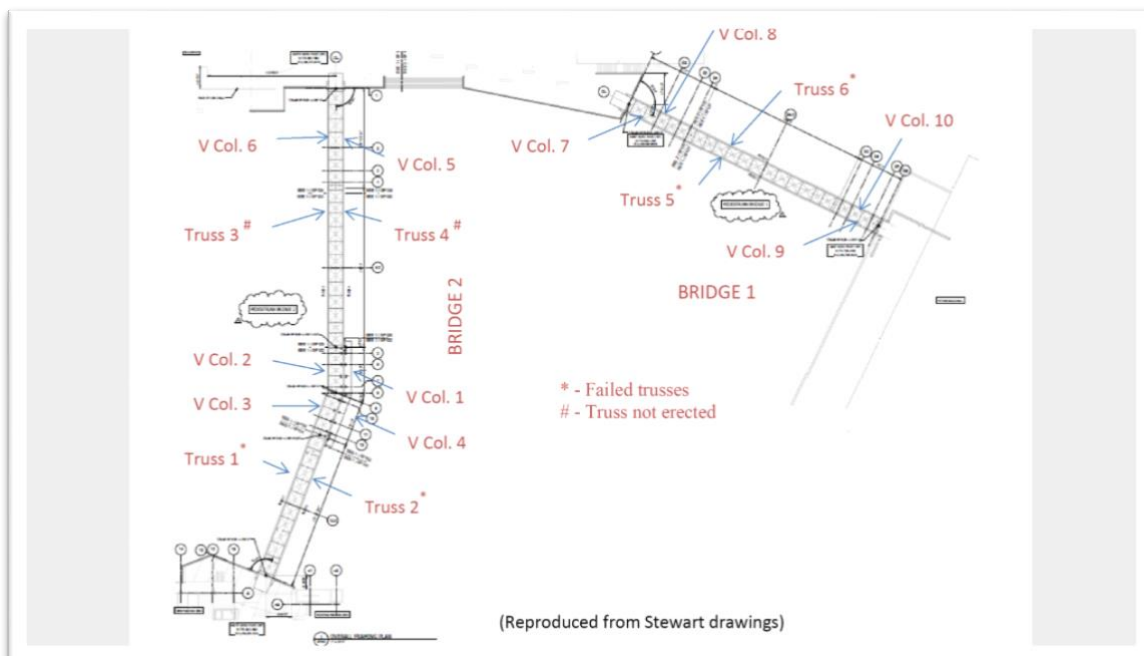
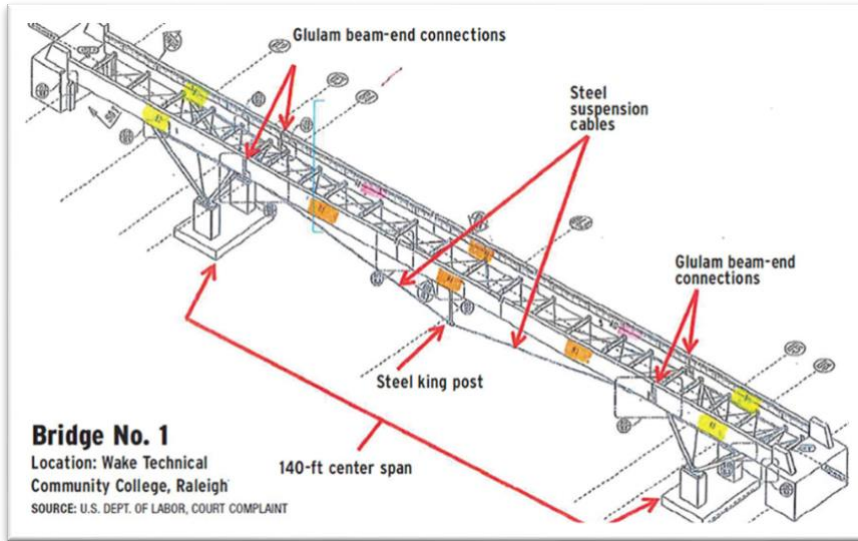
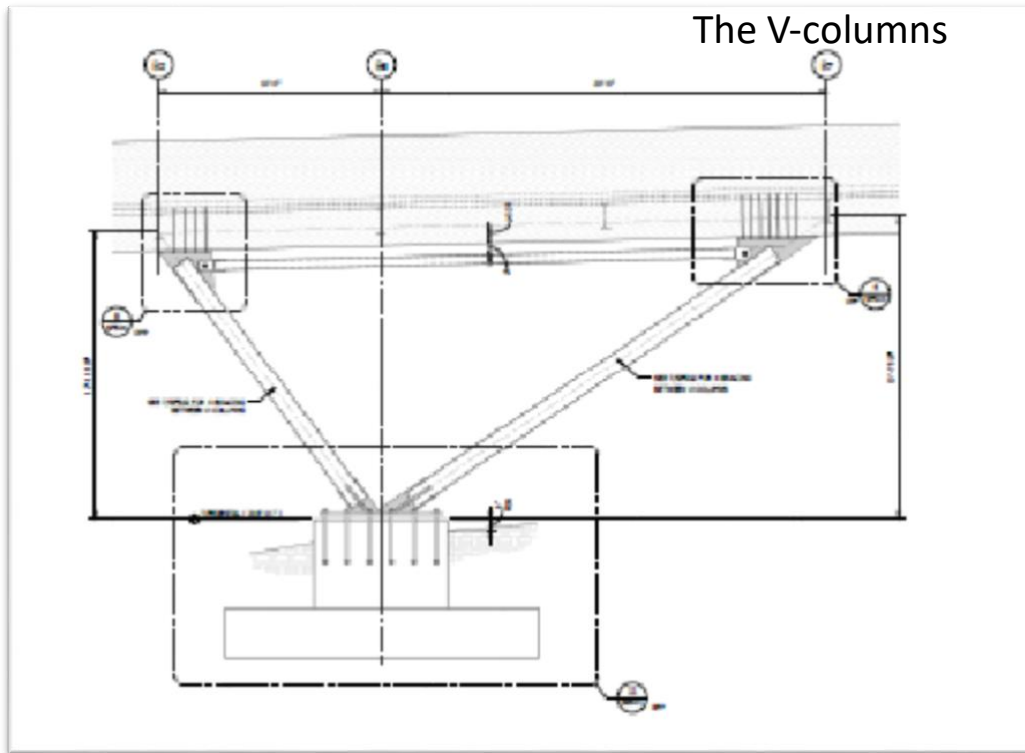
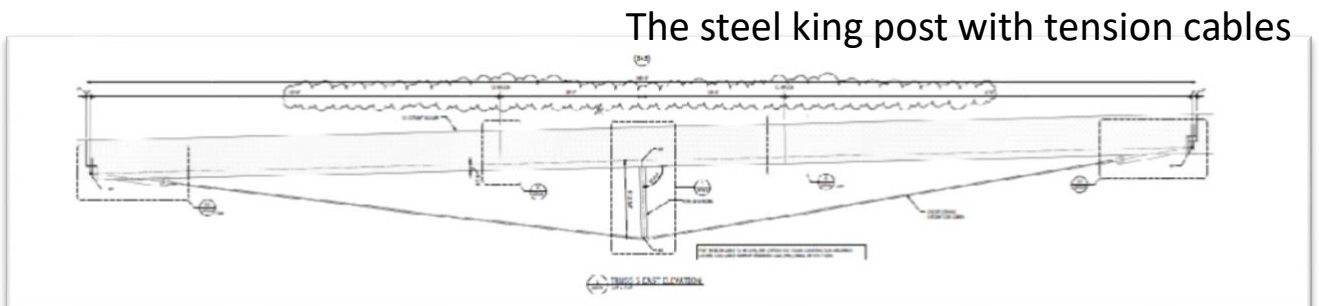
Two bridges had been erected, one with a 42.3 m length and one with a 39.6 m length. Beams were supported on concrete supports, with suspension cables and a central king post as well as V-shaped steel columns. Glulam beams were 340mm wide and 1.5 meter deep. The deck of the bridge consisted of poured-in-place concrete over a metal deck supported over steel beams.

1. Design flaws:
 - Inadequate design of notched connections in glulam beams, failing to account for tension perpendicular to grain.
 - During the shop drawing process it was agreed to introduce camber to the beams by tensioning the cables
 - The tension in the cables introduced tension stressed into the notches
 - The deck was attached at the bottom of the beams, pulling down the underside of the beams
2. Construction and quality control:
 - Lack of proper reinforcement at notched connections, the design engineer ignored the design standards and did not design/check the notches.
 - Inadequate site supervision and quality control.
3. Regulatory oversight and peer review:
 - Although the design was reviewed and checked at several stages by different entities, including the glulam manufacturer, the notches were never flagged as a potential design issue.

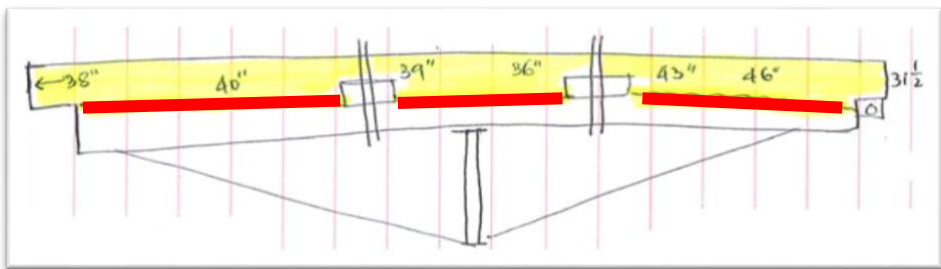
The Failure Bridge 1

The failure initiated at the splices and supports, which all had unreinforced notched supports.

- The cause of the failures was the structural design flaw from the notched glulam girders
- The notches were not in compliance with the applicable ANSI/AF&PA NDS-2005
- Several consultants did not notice the presence of the notches or neglected the opportunity to raise concern

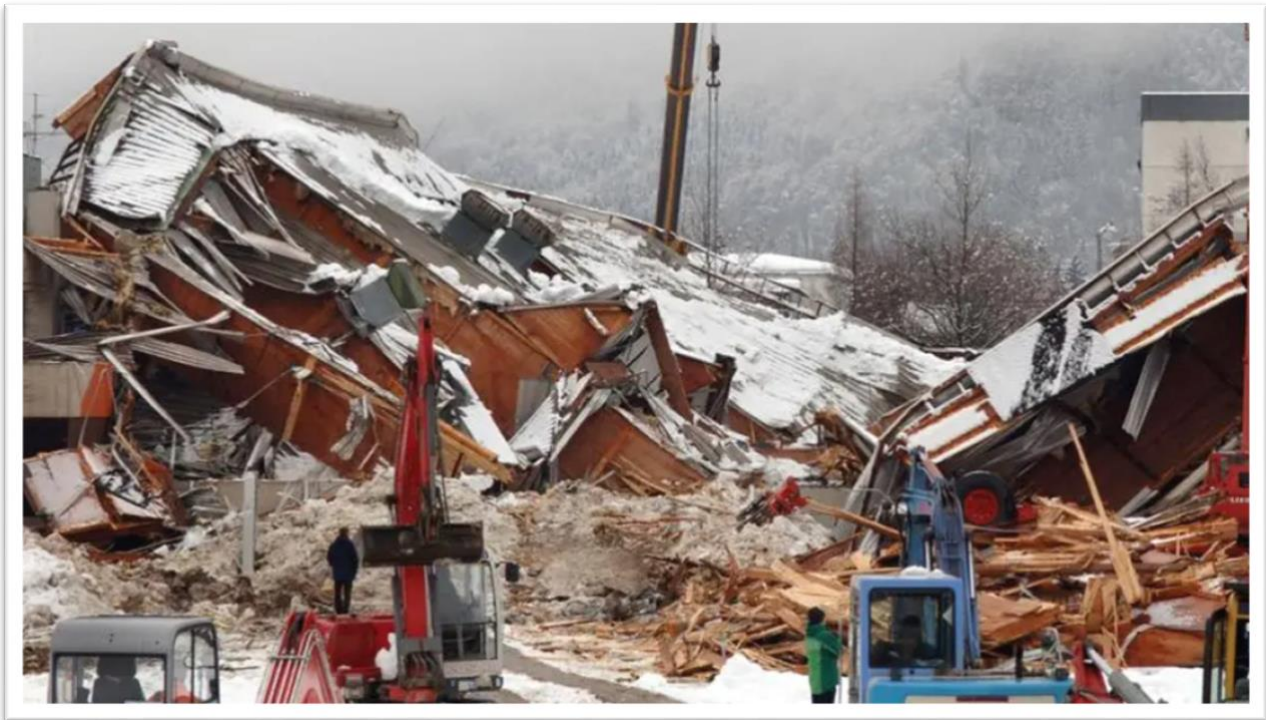
This case involved the collapse of a timber roof structure over an ice rink, built in 1972 with a span of 48 meters. During a winter day in 2006 the roof collapsed.

- Mistakes in design calculations.
- Use of finger-jointed timber sections without considering net section properties.
- Box girders were higher than allowed in appraisal (2.87 meters instead of 1.20 meters).
- Use of box beam sections that trapped moisture over time. Inadequate consideration of long-term moisture effects on the structure.

- Improper gluing techniques in the manufacture of box beams, the gluing between flanges and webs was not carried out according to the state of the art.
- Inappropriate use of urea-formaldehyde adhesive in a high-moisture environment.
- Water damage further weakened the finger joint.

- Lack of regular inspections and maintenance.
- The rink was enclosed with a glass façade at a later stage, changing the in-service conditions and therefore affecting the moisture content of the timber members.
- Moisture and condensation accumulated inside the hollow beams (due to cold radiation from ice)
- Known roof leaks were not adequately addressed.

- Avoid closed sections that can trap moisture in long-span structures. If closed sections are used, building physics principles should be applied to estimate the likely environmental conditions in the beam cavity.
